*The Brochs of
Mousa & Clickhimin*

The Brochs of Mousa & Clickhimin

JOHN HAMILTON, OBE, FSA

THE BROCHS OF MOUSA AND CLICKHIMIN, SHETLAND

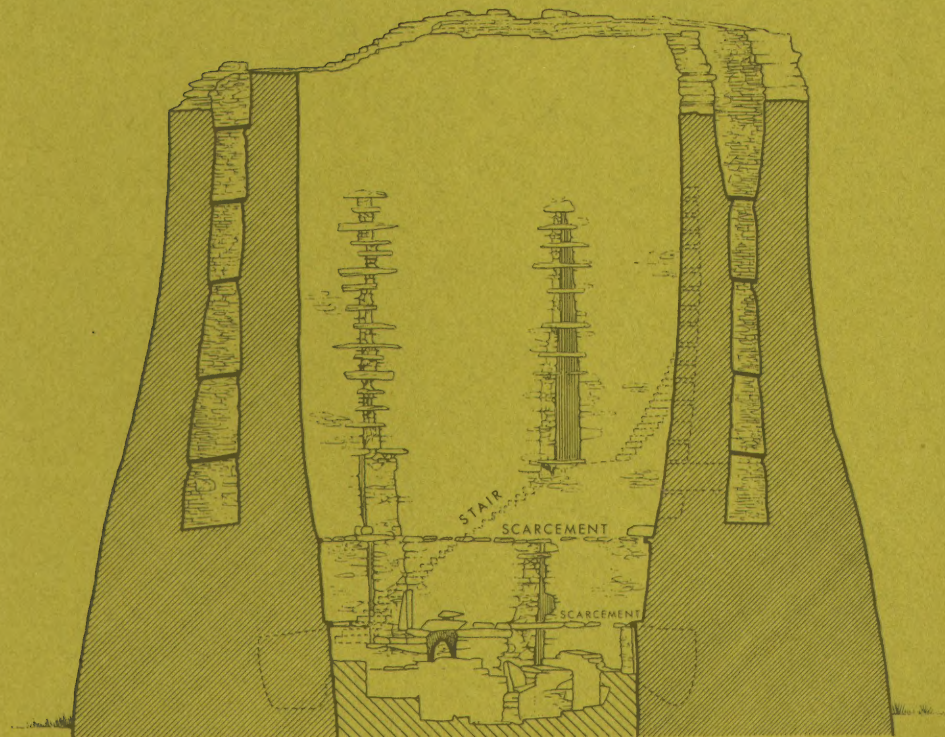
MOUSA BROCH

SECTION A - B

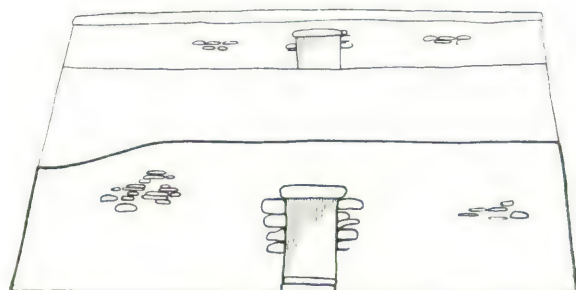
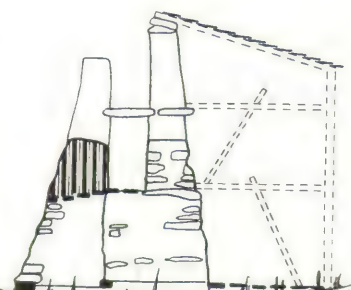
FRONT ELEVATION

CLICKHIMIN BLOCKHOUSE
